Rock Check Dams for Watershed Restoration?

Written by Dr. E. Lamar Smith, Ph.D., for the Arizona Association of Conservation Districts, March 2021

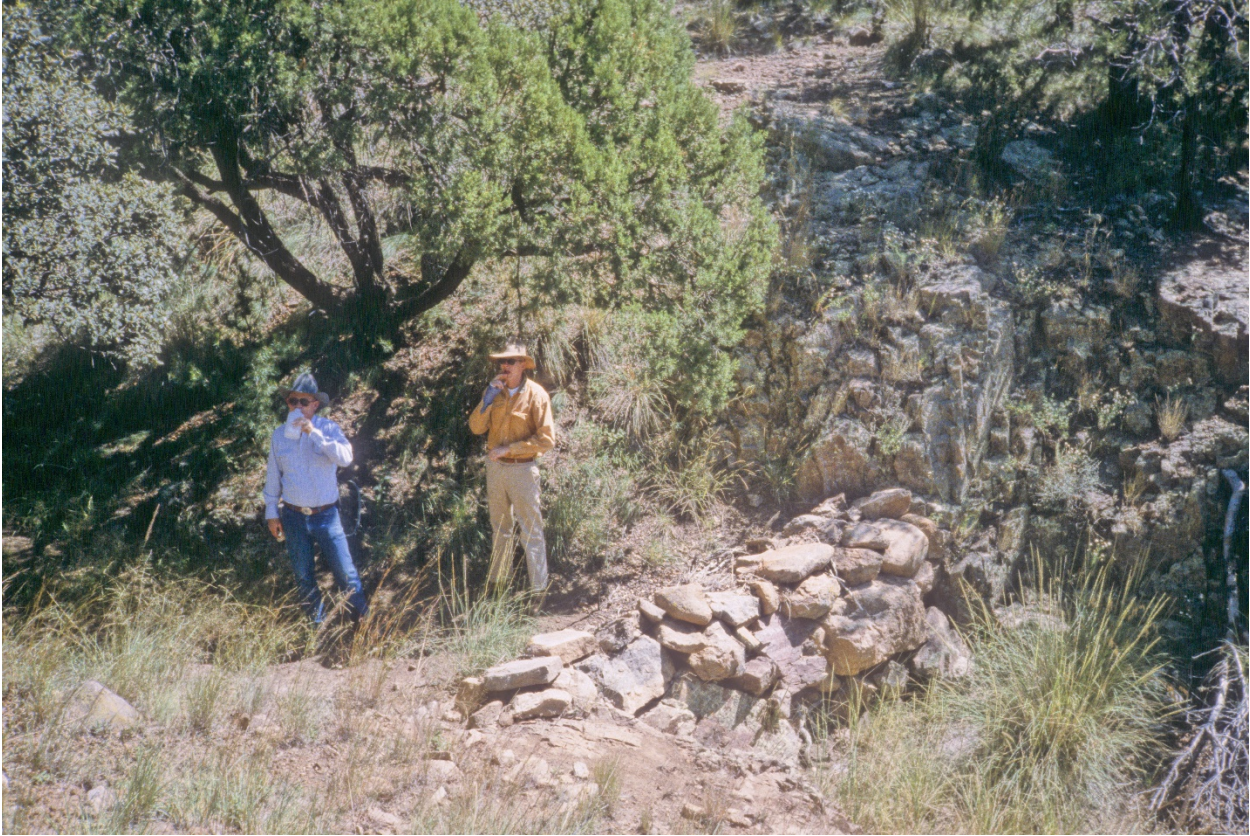
Figure 1. Loose rock dam on Joe Austin ranch 1993. Note size of rocks, size of dam and bedrock on both sides of channel. Larry Humphrey and Joe Austin in photo.

Loose rock dams have been built in a number of locations in Arizona, and in some cases have apparently been very successful. One of those is on the Joe Austin Ranch located on the west side of the Chiricahua Mountains in Cochise County. Mr. Austin has implemented an aggressive program of trying to improve watershed condition by using loose rock dams, brush control, and other measures. The loose rock dams have apparently been very effective in prolonging stream flow in drainages on the ranch. *Figures 1-3* show photos of some of the dams taken in 1993. As can be seen, there are significant differences between these dams and the ones studied on the Santa Rita. The ranch is located at a higher elevation and higher precipitation zone than the Santa Rita (probably about 5,000 feet and about 18-20 inches of precipitation). The vegetation is oak woodland and juniper, primarily, rather than semidesert grassland. The stream channels are developed in bedrock as are the adjacent soils. The loose rock dams used are larger and composed of larger rocks. Due to the bedrock, the tendency to washout around the ends or to scour below the dams would be much reduced compared to those built on alluvial materials on the Santa Rita.

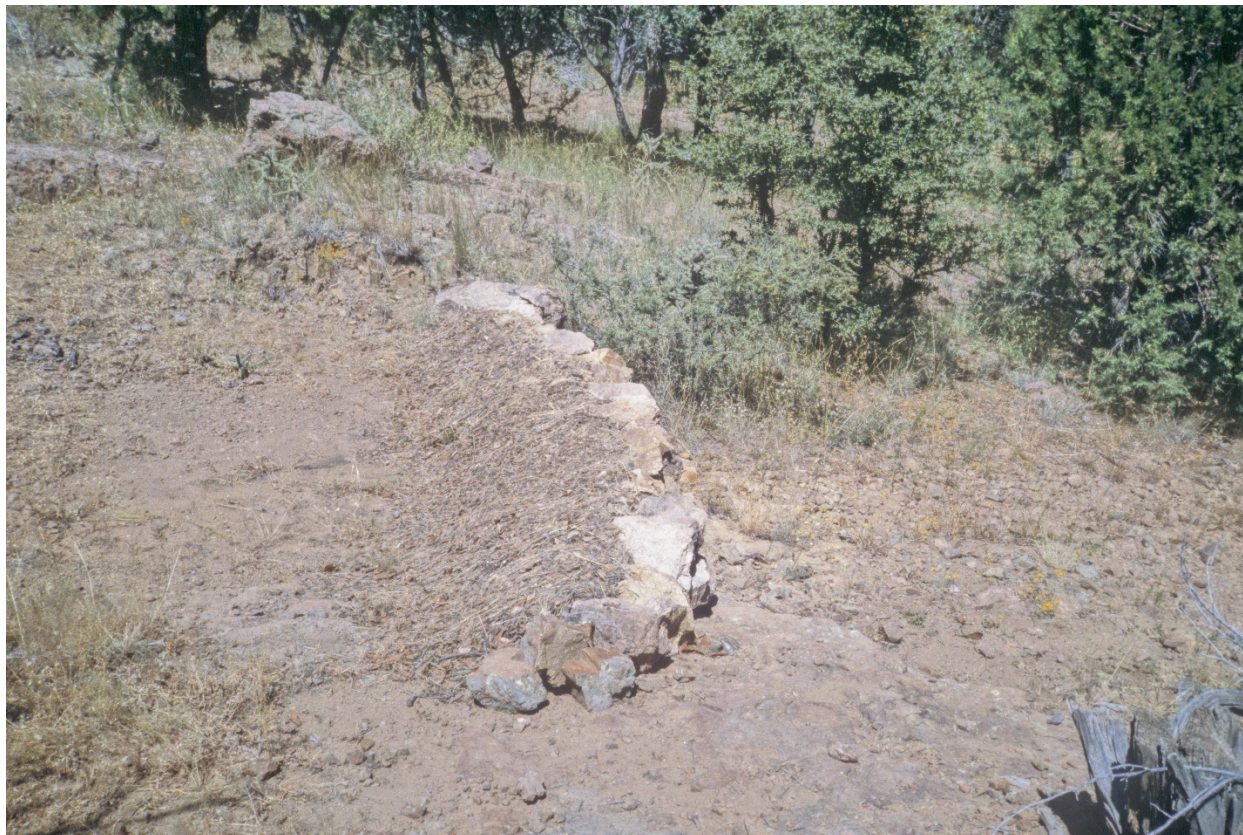
Figure 2. Loose rock dam on Joe Austin ranch 1993. Note debris on upside of dam indicating that it ran over.

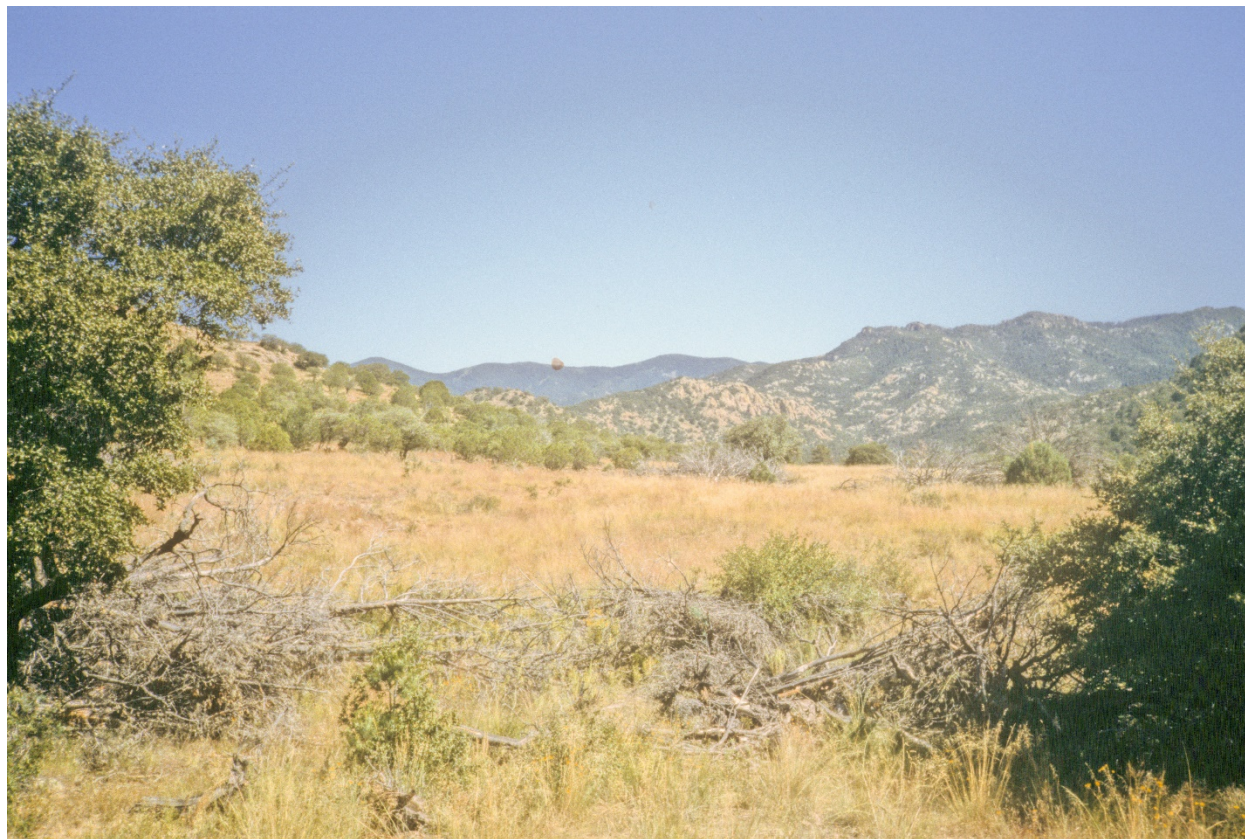
Figure 3 Brush control (mostly juniper) on Joe Austin ranch 1993.

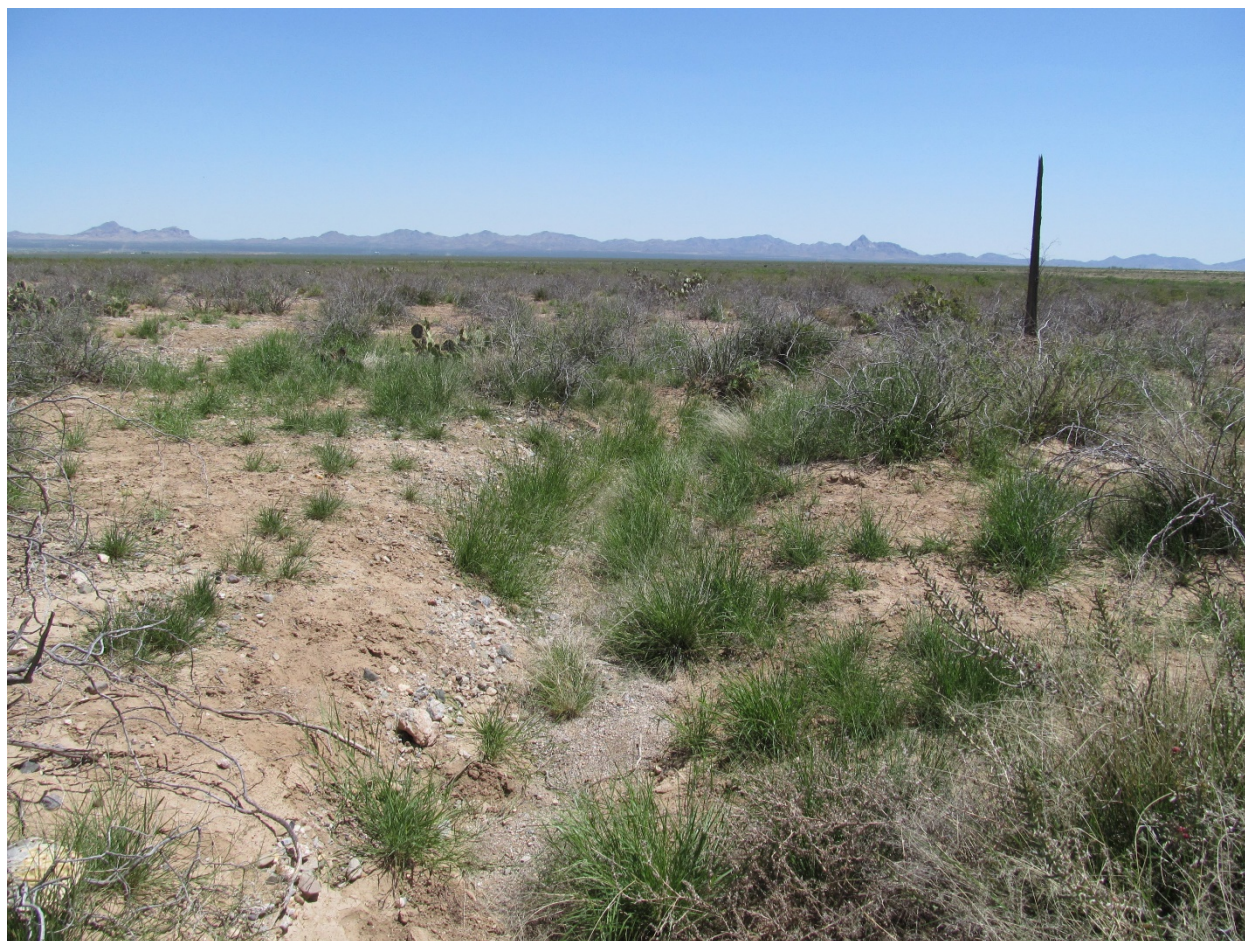
Figure 4 Lehmann lovegrass starting to stabilize eroded channel after creosotebush control near San Simon. No channel treatment was done.

5. As the ARS concluded, loose rock dams, or any other channel treatment, will not “restore” a watershed, although it may contribute to that restoration by helping to stabilize channels. Watershed restoration depends on establishing effective ground cover over the entire watershed, not just the channels. This cover will reduce or slow runoff thereby reducing the amount or rate of water flow in the channels, reducing sediment in the channels, and thus allowing vegetation to develop in those channels. In some cases, almost nothing that can feasibly be done will prevent bank cutting and head cutting in ephemeral channels due to altered flow regimes or lowered base levels due to arroyo cutting or other causes. *Figures 2 and 3* show eroded channels that are beginning to stabilize in the absence of any dams or other structures, partly as a result of brush control to help improve ground cover.

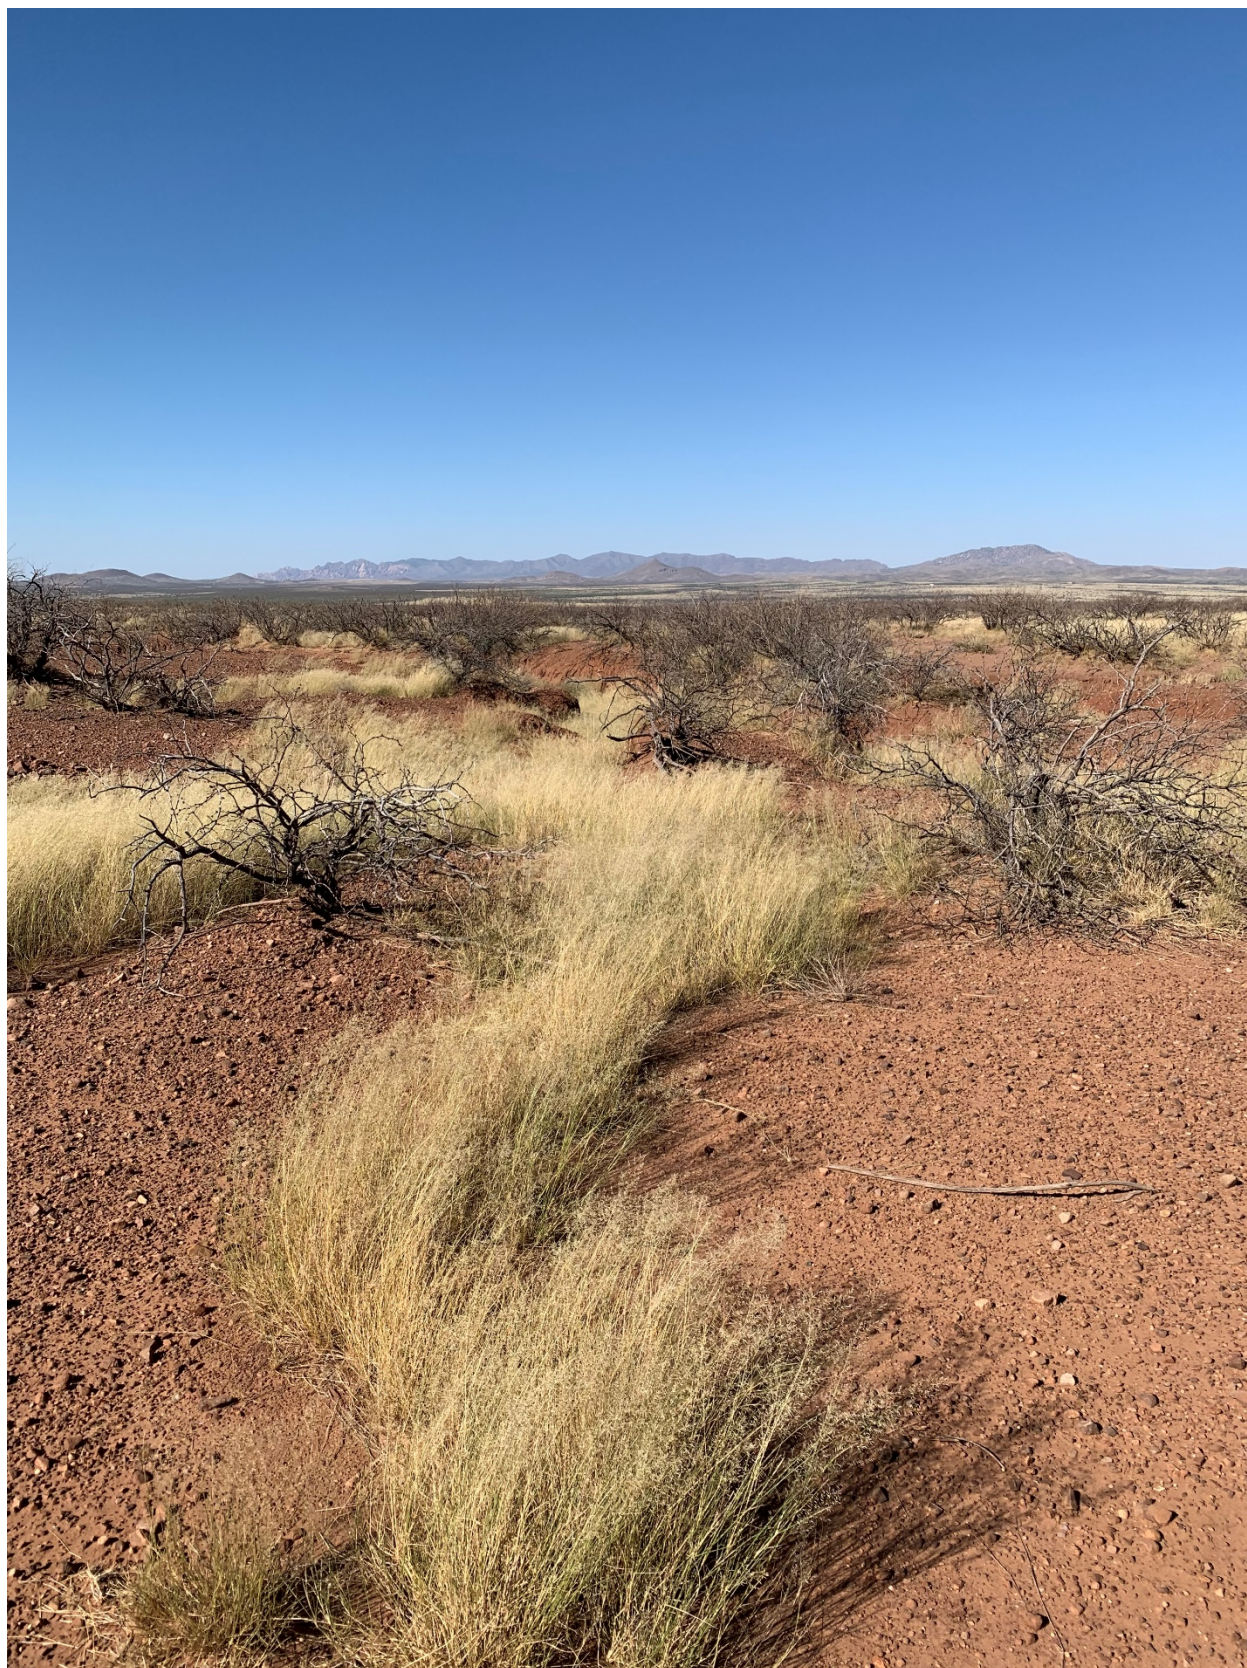
Figure 5 Lehmann lovegrass growing in eroded channel after control of mesquite and other shrubs – near Tombstone. No channel treatment was done.
